Tricolor Salvage

Collision with Kariba

Salvage operation

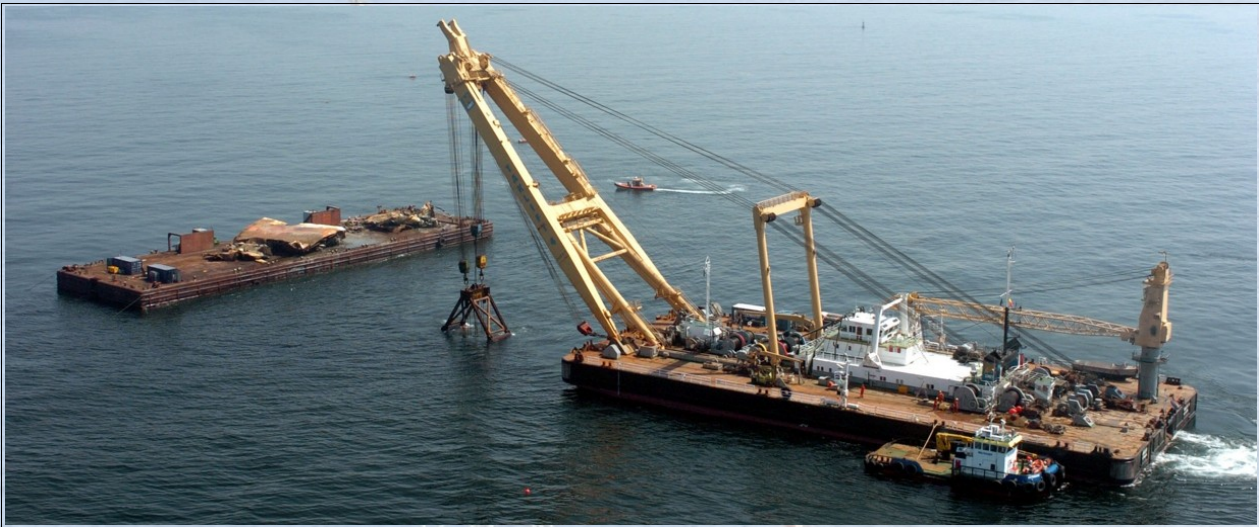
'Taklift 4', working at the wreck site

In May 2004 the salvage of the cut up wreck started, using the Taklift 4 and the Smit Barge 2 of Smit Salvage from Rotterdam. CT Systems, together with Thales Navigation (Now named Magellan Navigation), installed the Viking Survey software to handle the navigational, planning and positioning aspects of the operation.
